PETROLIA DAM

Manual for Operation and Maintenance

State Water Projects Bureau
Water Resources Division
Department of Natural Resources and Conservation
1520 East Sixth Avenue
P. O. Box 202301
Helena, MT 59620-2301

June 1995

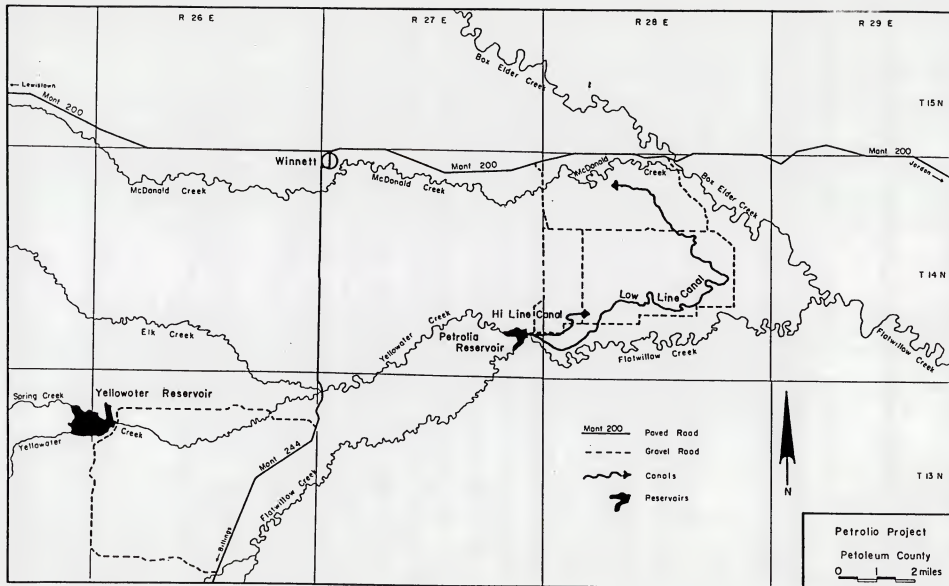
FIGURE 2. PROJECT AREA MAP

Petrolia Reservoir and Dam are located in Petroleum County approximately 7 miles southeast of the town of Winnett. (Figure 1) Petrolia Dam is located on Flatwillow Creek. (Figure 2) The Petrolia Water Users Association (herein called "association") operates the dam.

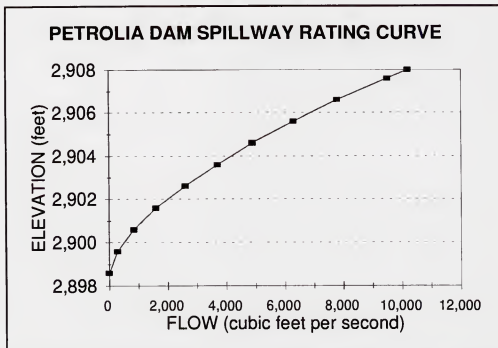
FIGURE A-1

Elevation <i>(feet)</i>	Flow <i>(cfs)</i>
2,898.6	0
2,899.6	290
2,900.6	840
2,901.6	1,600
2,902.6	2,600
2,903.6	3,700
2,804.6	4,900
2,905.6	6,300
2,906.6	7,800
2,907.6	9,500
2,908.0	10,200
2,908.6	11,300

Appurtenances at Petrolia Reservoir include the delivery canals, the spillway and the outlet works. The maximum combined capacity of the delivery canals is 120 cfs, design capacity (100 cfs for the lowline canal and 20 cfs for the highline canal). At the minimum dam crest elevation, the outlet works' capacity is 470 cfs. If the outlet works are operated far in excess of the delivery canals' capacity, the canals and structures can be damaged, without passing the excess flow through the low level outlet which returns the flow to Flatwillow creek. The spillway capacity at elevation 2,908 feet is 10,200 cfs. Outlet and spillway rating tables are shown in Appendix A.
